INDEX OF TEXAS ARCHAEOLOGY

Investigation and Recovery of USS Westfield (Site 41GV151) Galveston Bay, Galveston County, Texas

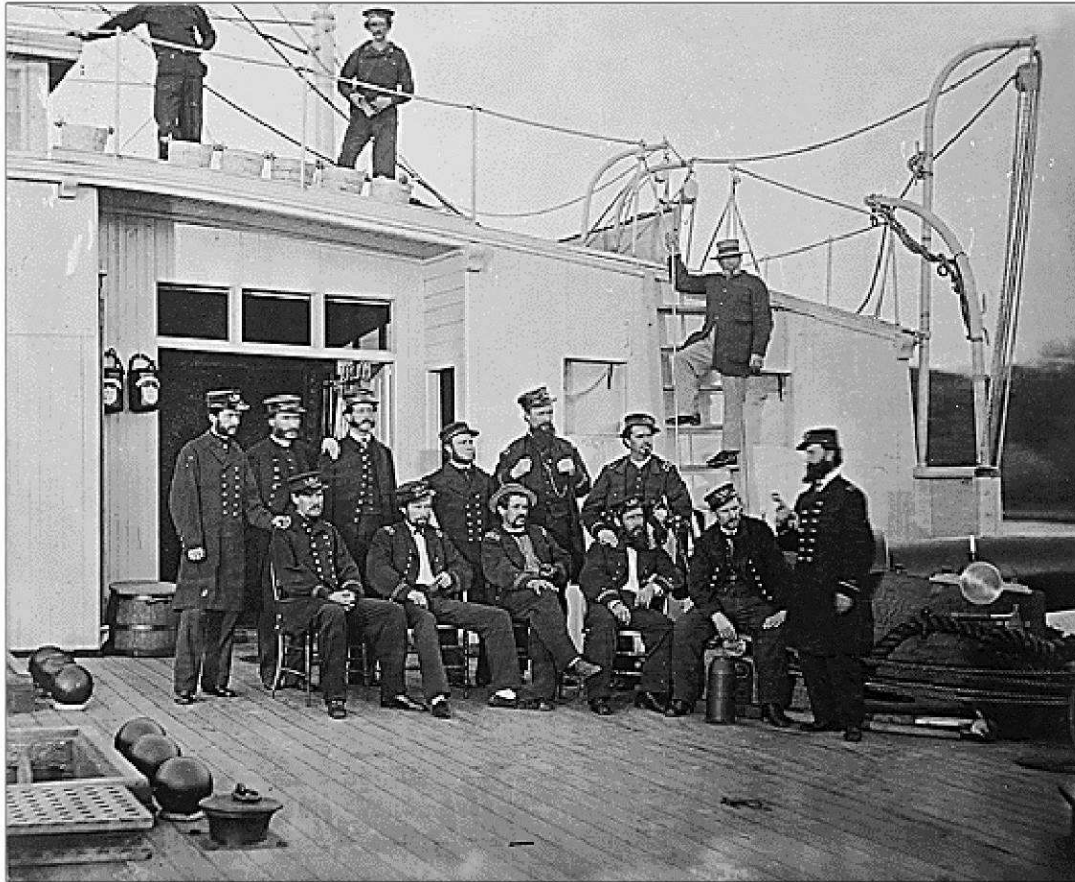
Other U.S. Navy ferry-gunboats such as *Whitehall*, *Ellen*, *Morris*, *Commodore Barney*, and *Commodore Perry* were likewise reinforced with plating, though *Commodore Perry* may be the only of these aforementioned vessels plated along its entire length (Minick 1962). The smaller 2-x-3-ft plates at the bow and stern of *Westfield* (the 1862 Memphis sketch; see Figure 3) suggest the smaller iron "hinged" plates from the gun decks of *Morris*, *Satellite* (a converted tugboat), and *Commodore Perry* (see figures 4, 5, and 6). These vessels employed a type of hinged metal plating that could be raised or lowered at discretion to facilitate use of the cannon. A photograph of *Commodore Perry*'s deck shows the treatment of the enclosed deck cabin (Figure 7).

FIGURE 7. DECK OF *COMMODORE PERRY* CA. 1860–1865 (NATIONAL ARCHIVES, MATHEW BRADY COLLECTION, ARC No. 524570)

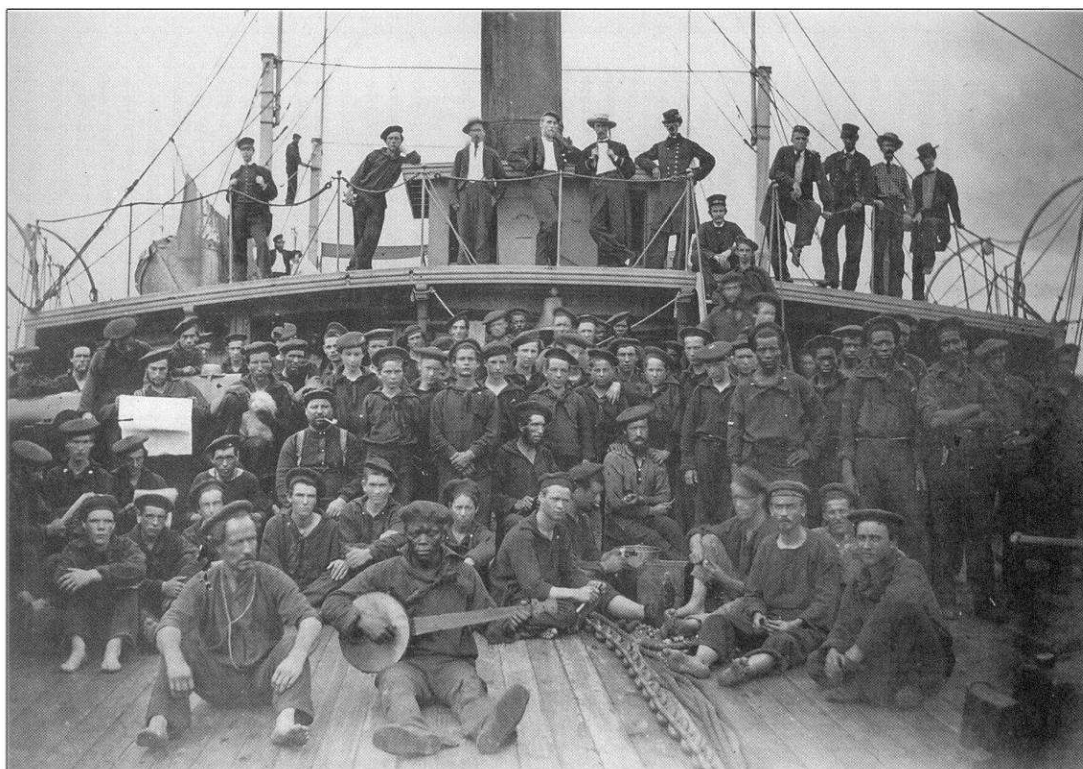
Details of the new deck arrangement for the converted gunboats are discernible in photographs of USS *Hunchback*, Simonson's first two-decked Staten Island ferry. Historic images by Mathew Brady show the vessel prior to and following her conversion as a gunboat (Figure 8). The upper promenade/saloon deck has been removed. The deck cabin, formerly open, has been enclosed, possibly similar to the treatment of USS *Morris*. The newly enclosed deck, hinged plating, boat davits, and two of the deck guns, a Parrott rifle and Dahlgren, are all visible in the photograph of *Morris* (see Figure 4). Sections of the deck cabin on *Commodore Hull*, for example, were compartmentalized to include officers' quarters, storerooms, and galleys (Minick 1962:427).

FIGURE 8. USS *HUNCHBACK* IN 1859 BEFORE CONVERSION (TOP)
(IMAGE COURTESY OF TREVOR GHERARDI) AND IN CA. 1860–1865 AFTER CONVERSION (BOTTOM)
(NATIONAL ARCHIVES, MATHEW BRADY COLLECTION ARC No. 526207)

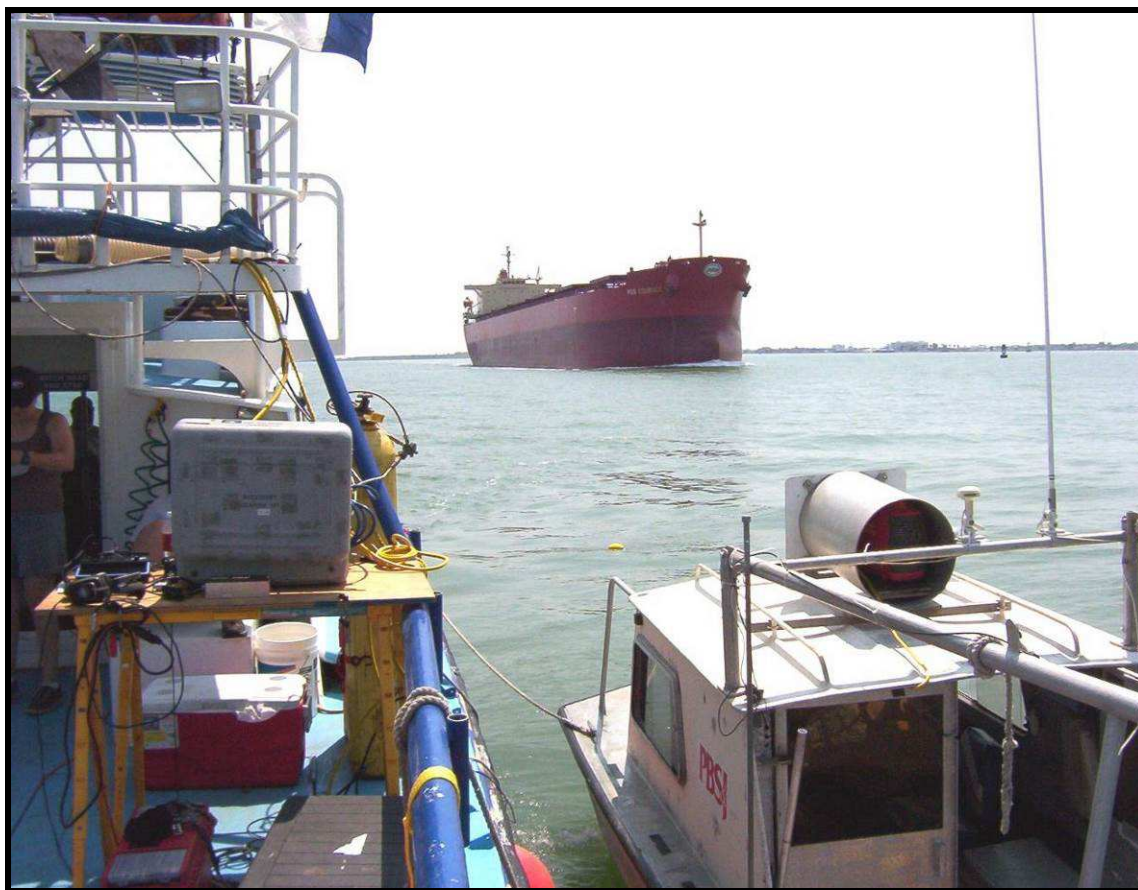
FIGURE 25. PROXIMITY OF DIVE ANCHORAGE TO SHIP TRAFFIC

The proximity of Anomaly GV0032 and *Westfield* to the TCC (Figure 25) necessitated bringing divers to the surface when ships passed. The large displacement of water by ships creates a hazardous current as they pass and can potentially impact the anchorage of the dive vessel. The diver ascent began at least 10 minutes prior to the arrival of each ship in order to allow a margin of safety. Passage of ships on the HGNC did not create a noticeable current; however, the diver was recalled from the water whenever the captain of an approaching vessel on the HGNC made this request.

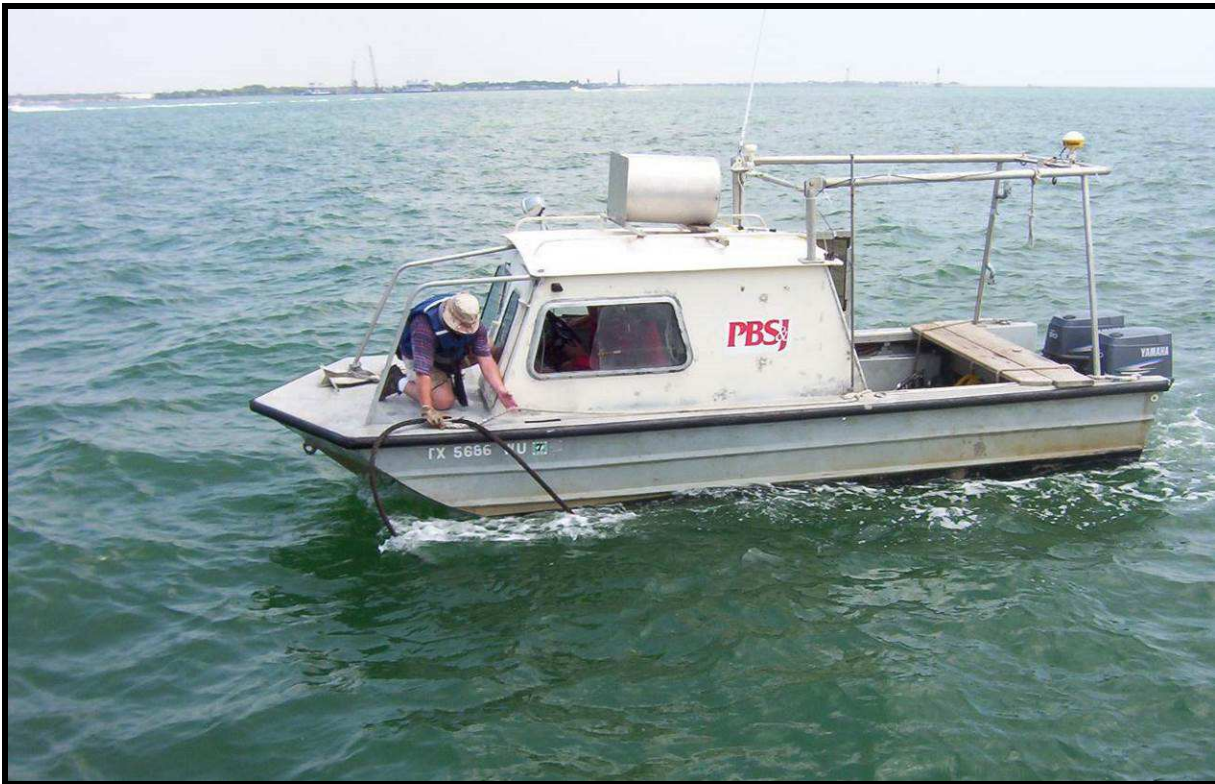
FIGURE 26. DRAGGING CABLE ANOMALY SOURCE AWAY FROM GV0032

and returned to the site. Subsurface probing at the location of these objects returned negative results. At the conclusion of the day's diving operations, a length of 1-1½-inch braided steel cable was snagged by the starboard stern anchor. Its weight prohibited lifting it on board, so it was dragged away from the dive vessel (Figure 26) and disposed of outside of navigation channels. Examination of the boat location at the time of the dives and during the anchoring process suggested that the cable might be the source of Anomaly GV0032. A subsequent magnetometer survey was conducted over the area, which returned negative results (Figure 27) and proved that this length of modern cable was the source of Anomaly GV0032. The miscellaneous ferrous concretions were not substantial enough to create a magnetic anomaly.

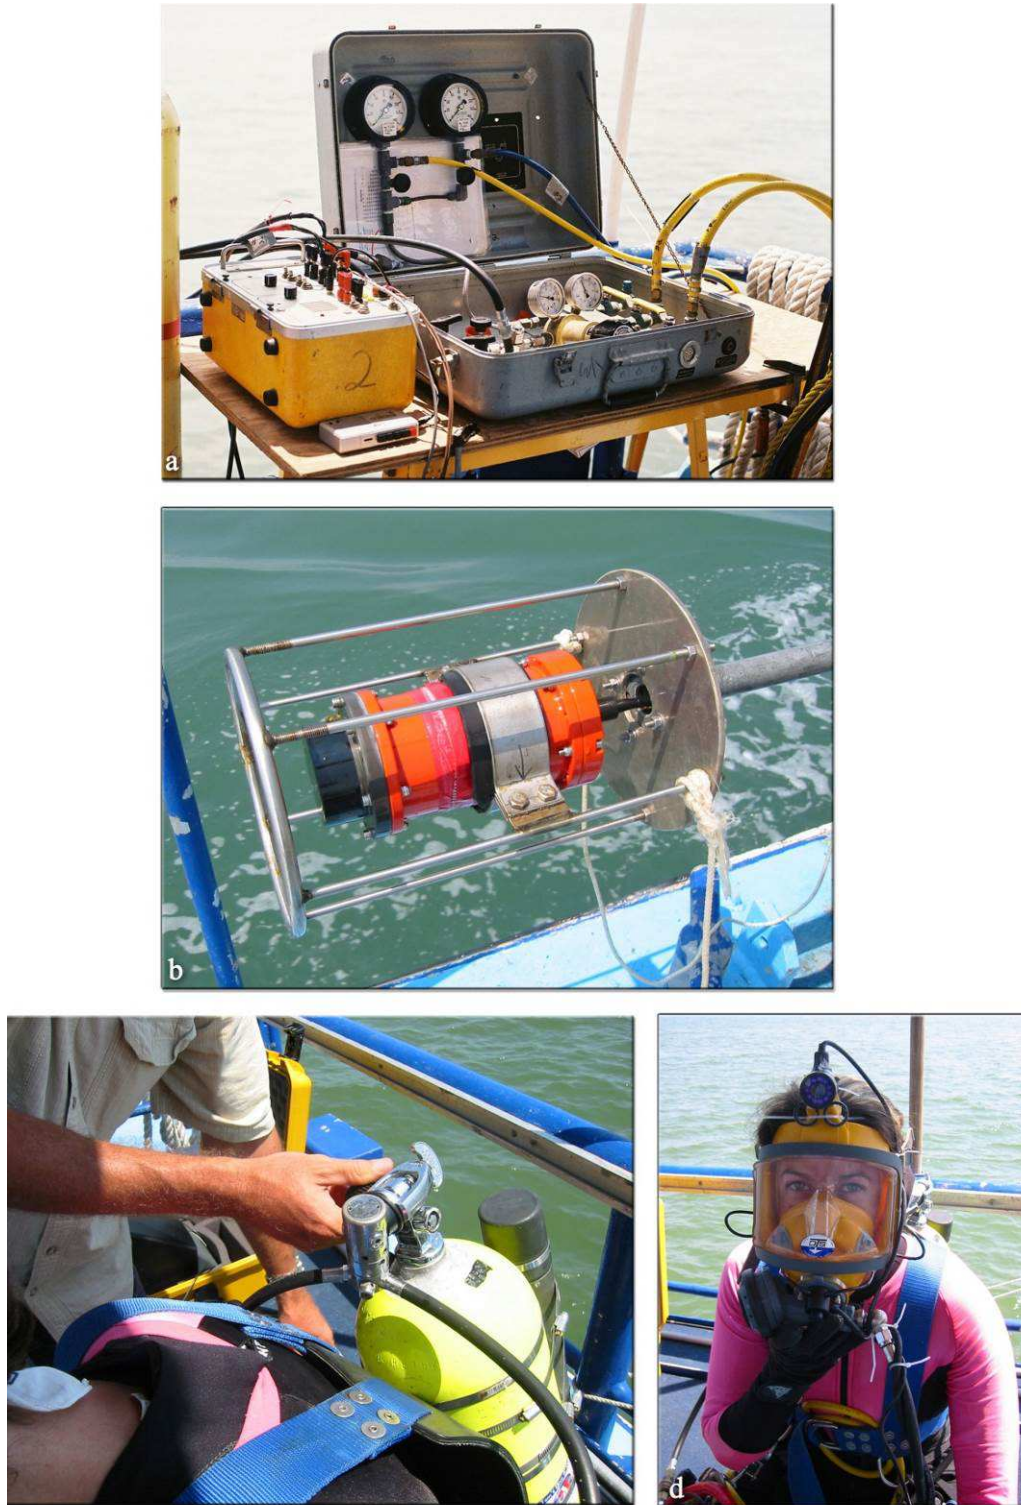
FIGURE 29. DIVE AND POSITIONING OF EQUIPMENT USED FOR D.O. 0005

Another significant improvement over the 2005 field session was the addition of audio and video recording capabilities. Beginning with Dive 7 (of 26), diver video and audio were recorded. A low-light camera was fastened to the top of the primary dive mask (Figure 29d). The video feed was displayed on a deck monitor while it was recorded, so persons keeping dive notes on the boat could

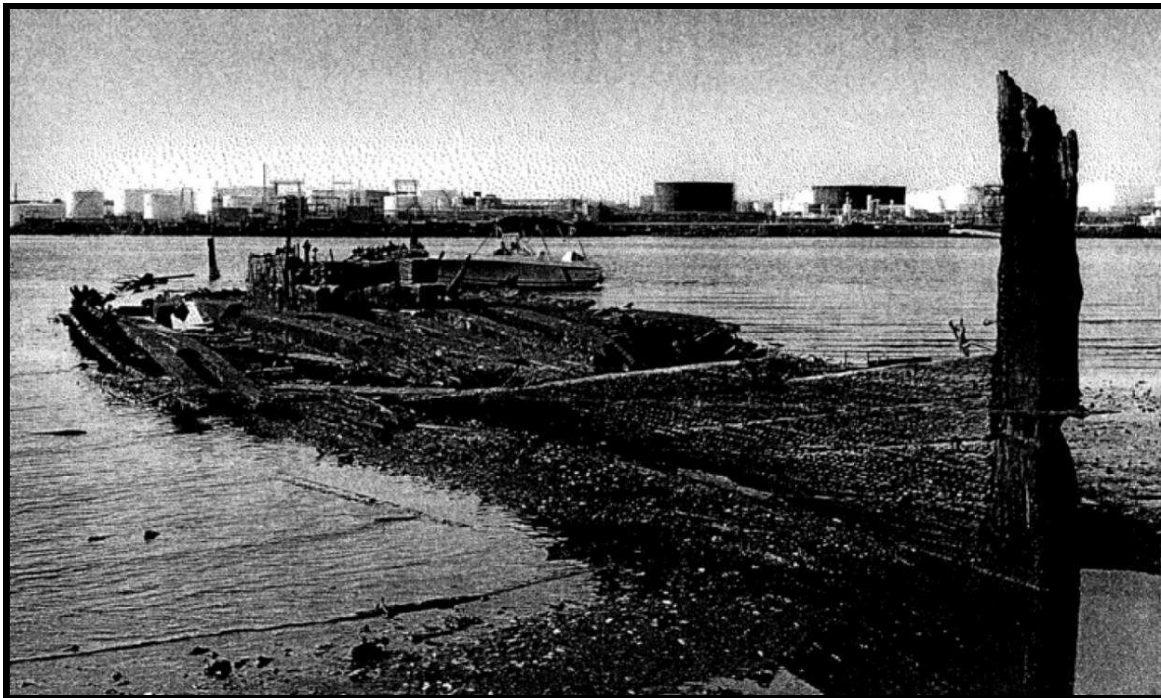
FIGURE 45. *WESTFIELD II* (JAMES ET AL. 1999)

examined by Panamerican Consultants in the late 1990s. The lower hull of the ferry, consisting of frame pairs, sister keelsons, engine bed timbers, veiling, and hull planking, was in excellent

The Simonson-built Staten Island ferry *Westfield II* (Figure 2b) was still in service into the early 1900s, even after the explosion of its boiler in 1871. That event is still considered the worst disaster in the history of the ferry service, and yet in spite of the catastrophe, at the time of its retirement in 1905 it held the record for the longest tenure of service in the fleet at 44 years (Scull 1982:10). The remnants of two wrecked ferryboats near that of *Astoria* in New York Harbor are believed to be *Westfield II* and *Middleton*. The wreck of *Westfield II* (Figure 45), known as vessel no. 58, was

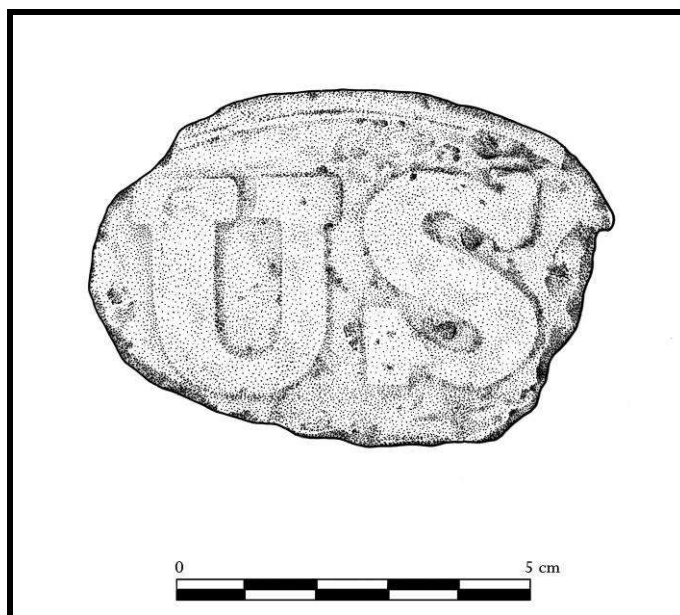
Preliminary archeological dives in 2005, 2006 and 2009 discovered a relatively small number of artifacts of a more personal nature than the larger fragments of mostly iron that dominated the visible debris field. A historic ginger bottle and sherds of glass were observed in 2006. A complete, intrusive historic Billy Baxter ginger ale bottle (circa 1920) also was discovered, suggesting other fragile, light-weight artifacts may have survived. A Union belt buckle was recovered during fieldwork in May 2009 (Figure 46).

Figure 46. Union Belt Buckle
(Illustration by A. Borgens 2009)

A 4-x-5-ft area of unit 15 was cleared of loose shell hash that was roughly 6 inches deep. The diver conducting the dredging was unsure whether sterile clay was reached during the course of work due to the dense nature of the sediment underlying the shell hash. One large immovable artifact was encountered buried in the excavation unit. A total of three small artifacts were collected from the top 6 inches of shell hash; two fastenerlike concretions were on top of the sediment. The most diagnostic artifact recovered during the May 2009 field session was collected during the final dive at unit 15, while retrieving a sample of shell hash. This was a lead Union belt buckle stamped “US” (Artifact 6; see Figure 46). The outer brass plating had long since deteriorated.

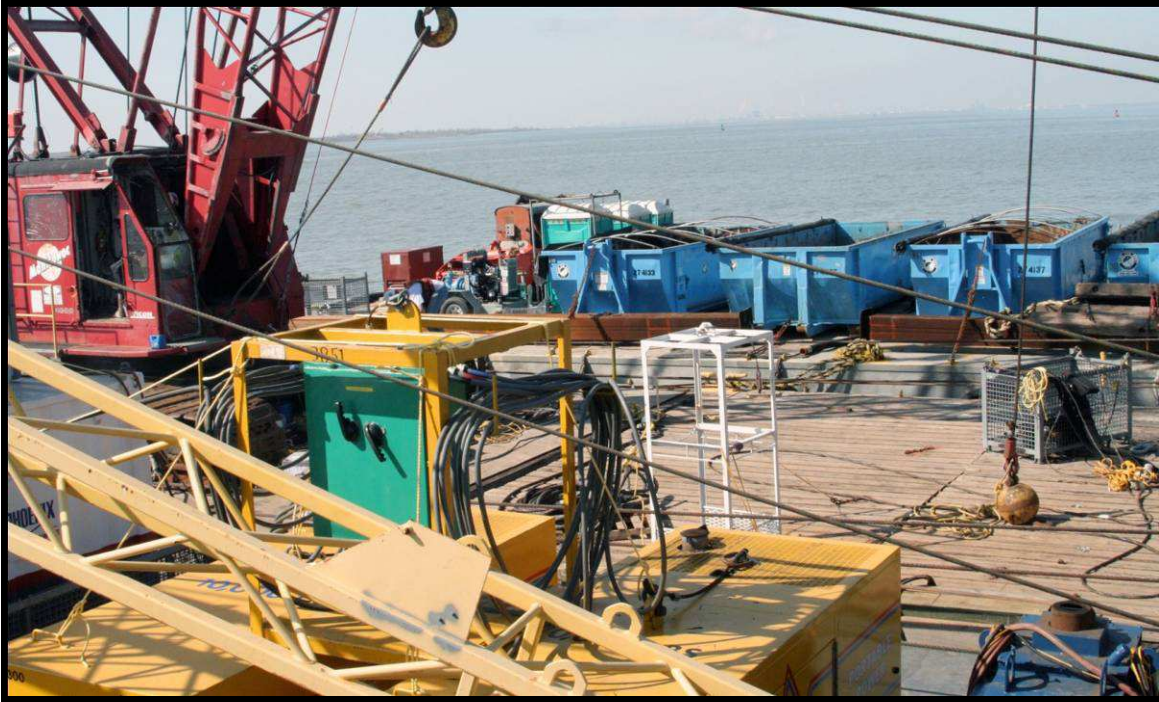
FIGURE 53. DETAIL OF BARGES DURING MOBILIZATION (PHOTOGRAPH BY AMY BORGENS)

Mobilization of the on-site Galveston fieldwork took four days, November 14–17, after which the first phase was commenced. Work vessels included a 120-x-40-ft barge equipped with a large (138-ton) crane. The barge included a “laydown” and sorting area for large artifacts, and the vessel positioning and navigation operations (“survey shack”); a 100-ft-long barge, equipped with a small (16-ton) crane, housed the diver operations including the communications shack, air compressor stations, recompression chamber, generators, and water pumps; and a 100-x-40-ft materials barge, carried up to nine roll-off/filter boxes used for artifact wet storage, sediment storage, and large artifact screening. The USACE contracted SUPSALV and their subcontractor DonJon Marine Co., Inc. for set-up and management of the Galveston-based barge operations. The barges and cranes were owned and operated by J&S Contractors of Freeport, Texas. Diving and survey/navigation personnel and equipment were provided by Phoenix International (under contract with SUPSALV). Atkins archeologists coordinated and supervised collection protocols to ensure adherence to the research design.

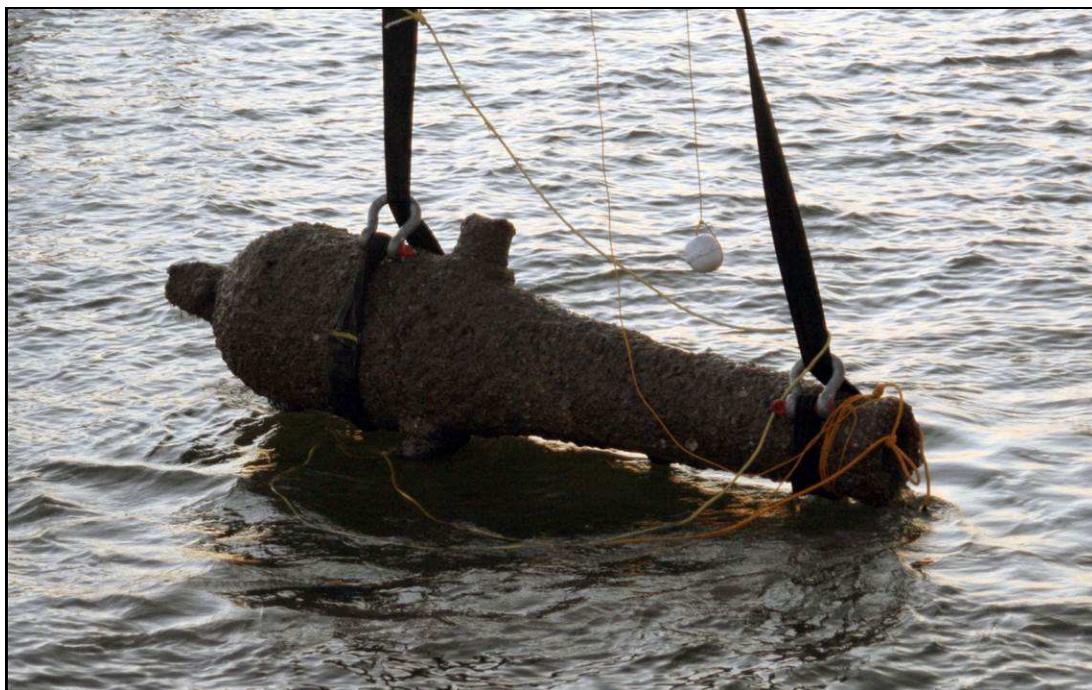
FIGURE 55. RECOVERY OF DAHLGREN CANNON (PHOTOGRAPH BY AMY BORGENS)

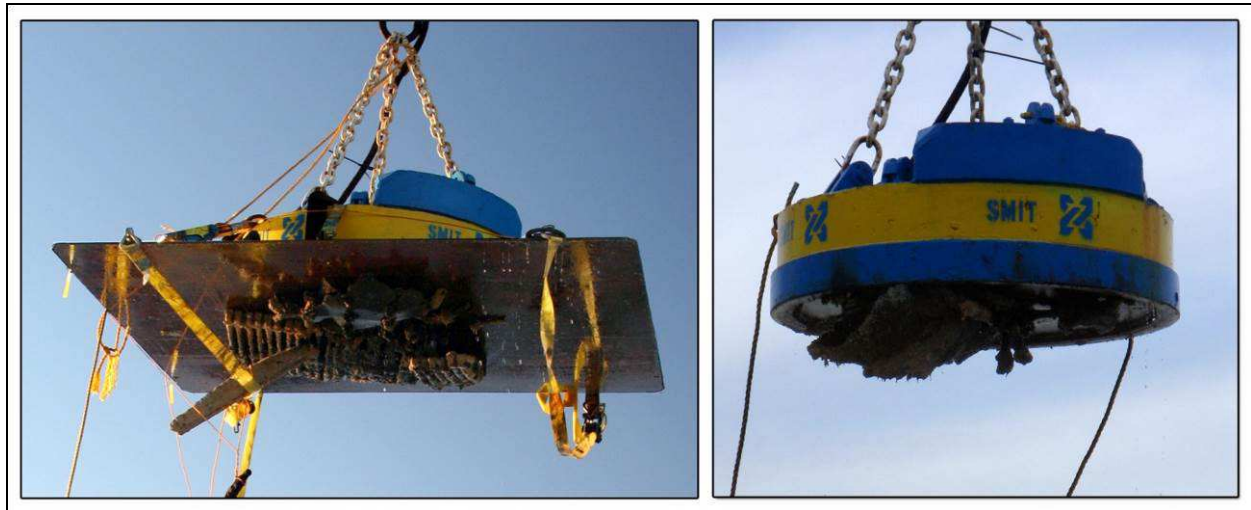
FIGURE 56. DETAIL OF ELECTROMAGNET (WITH AND WITHOUT ATTACHED PLATE)

The second phase of operations, conducted November 25–27, involved using an electromagnet to systematically remove ferrous artifacts from the seafloor. The magnet, owned and operated by SMIT Americas, Inc., measured 5.5 ft in diameter with a lift capacity of 33 tons and was deployed using the large crane (Figure 56). The purpose of the magnet was to remove known artifacts that were too large for recovery using the clamshell yet too numerous to recover by diving as originally intended. Weather delays necessitated that this method be considered in order to put the project back on schedule. All agency archeologists were consulted regarding this decision and agreed to test this methodology. The general effectiveness and safety (to personnel and artifacts) of the magnet was successfully demonstrated to the satisfaction of archeologists on the barge deck using modern objects prior to its use on the wreck site. An attempt was made to increase the effective surface area of the magnet by attaching a 10-x-8-ft steel plate (see Figure 56); however, this method proved unsatisfactory, as the magnetic charge dissipated substantially outside of the central 5.5-ft-

diameter magnet surface. Positioning of the magnet was accomplished using Cable Arm's ClamVision software, a fully integrated dredge positioning system that gave the crane operator a real time view of the barge and magnet positions as they existed over the project area. ClamVision used a GPS data stream to position the magnet over the target location within the site grid. The software displayed the 3D surface of the seafloor at the wreck site created from the 2009 multibeam data. The position of the magnet on the seafloor was also visible in real time using sector-scan sonar.

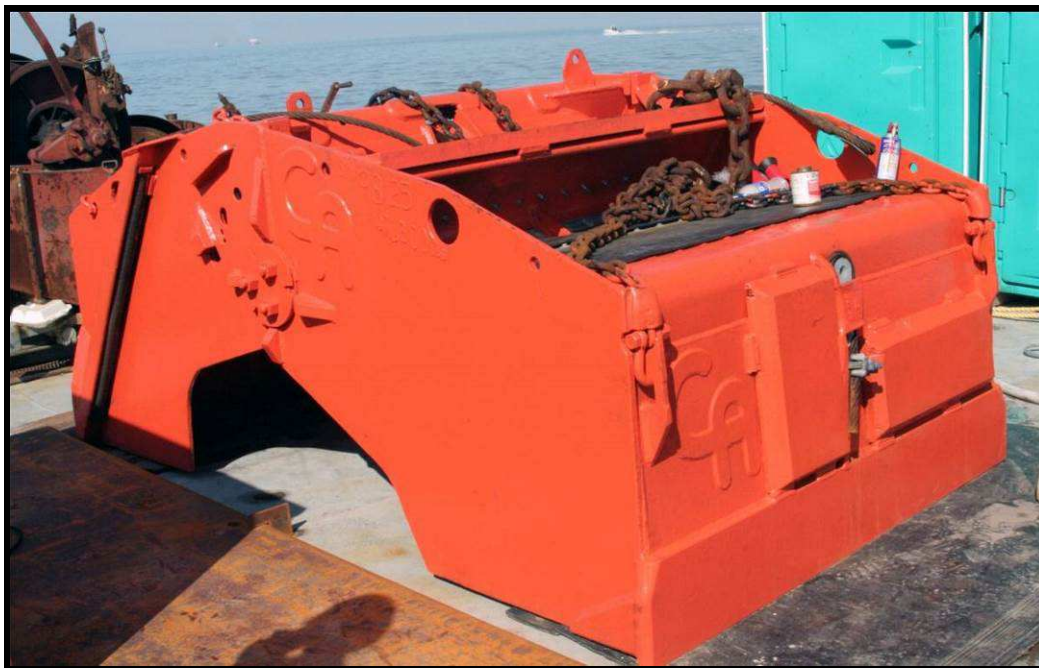
FIGURE 57. ENVIRONMENTAL CLAMSHELL DREDGE

The final phase of the Galveston fieldwork consisted of systematic clamshell dredge recovery of sediment from the site. The clamshell was a 3-cubic-yard smooth environmental bucket. The smooth environmental bucket does not have teeth and is less inclined to dig into the underlying clay bed. The clamshell measured 6 x 9 ft when open (Figure 57) and weighed 5,100 pounds empty. Environmental clamshell buckets are generally used to remove contaminated materials and, as such are designed to minimize resuspension of sediments and to protect water quality. They are manufactured to ensure minimal loss of materials during extraction.

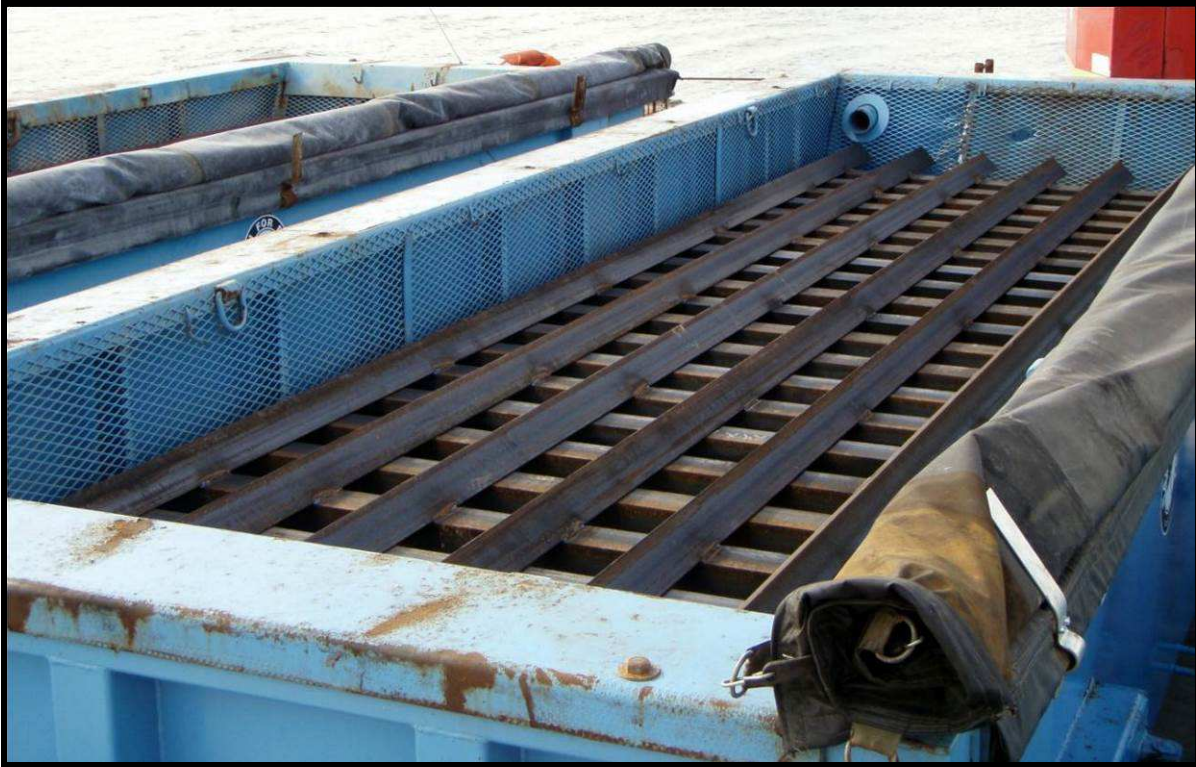
FIGURE 59. FILTER BOX WITH INSET 6-INCH MEC SCREEN INSERTED (PHOTOGRAPH BY SARA LAURENCE)

Each clamshell load was placed into a specialized 23-ft-long x 8-ft-wide x 5-ft-deep, watertight roll-off box containing an interior lining of steel screens of $\frac{1}{4}$ inch on the bottom and 1-inch screens on the side (termed a “filter box”). Atkins archeologists were present on the spud barge and materials barge to maintain a record of provenience for each clamshell load and filter box. Each filter box contained a removable inset 6-inch steel screen so that any MEC within the sediment could be identified and removed during this phase of the operation (Figure 59). The loaded clamshell was placed on top of the 6-inch screen and opened. Donjon personnel used water hoses to rinse sediment and clay from the matrix while Atkins archeologists supervised the recovery of artifacts from the screen. Any artifacts larger than 6 inches (or otherwise visible in the sediment/shell hash matrix) were removed and placed in wet storage containers, labeled with the corresponding clamshell and grid number for provenience. The remaining materials were rinsed through the 6-inch screen to be collected on the underlying $\frac{1}{4}$ -inch screen.

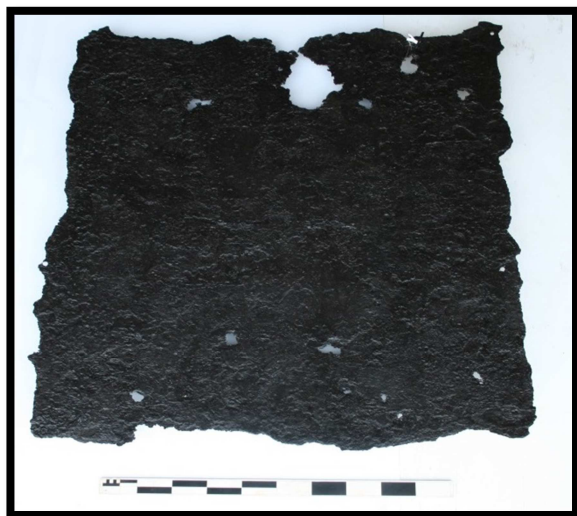
FIGURE 64: SQUARE ARMORED PLATE
(ARTIFACT 108-001; SCALE CM/DM)

Six boilerplates used as armor were recovered relatively intact (Artifacts 102-006, 108-001, 111-001, 111-002, 111-003, and 122-045). Their sizes varied by a few inches due to corrosion along the plates' edges; however, the most intact plate (Artifact 108-001), measured 5.0 x 5.0 ft, allowing the original size to be determined (Figure 64). This size is consistent with the size of plates covering the cabin in the Memphis drawing of *Westfield* (Figure 3). Conservators determined that the plates were originally 5/16-inch thick, sufficient only to protect the gun crews from small arms fire.

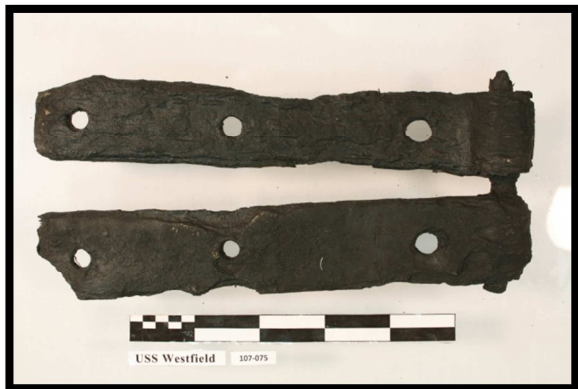
FIGURE 66. ARMOR HINGE
(ARTIFACT 107-075; SCALE CM)

The Memphis drawing (Figure 3) depicts that the gun decks at the bow and stern, were protected by smaller hinged metal plates. In the drawing these are clearly shown as less than half the width of the 5-ft plates protecting the cabin. These smaller plates could be raised or lowered as required when using the pivot guns. Artifact 123-037 and 125-001 are the best preserved examples out of five that were identified conclusively as the smaller size of hinged armor plates (Artifacts 103-076, 110-002, 110-003, 123-037, and 125-001). These plates measure approximately 3.0 x 2.5 ft. Their height indicates that when folded down, 2 ft of the armored bulwarks remained standing as shown in Figure 3 for both the broadside gun ports and the pivot gun positions. Hinges were preserved on several of these plates. Hinge measurements are consistent with those used on the broadside gun port plate (Figure 65). Numerous hinges also were found separated from the armor plates, often with their upper and lower components. Figure 66 displays some of these examples with their original pivot bolts still intact (Artifacts 103-075, 104-015, and 107-075).

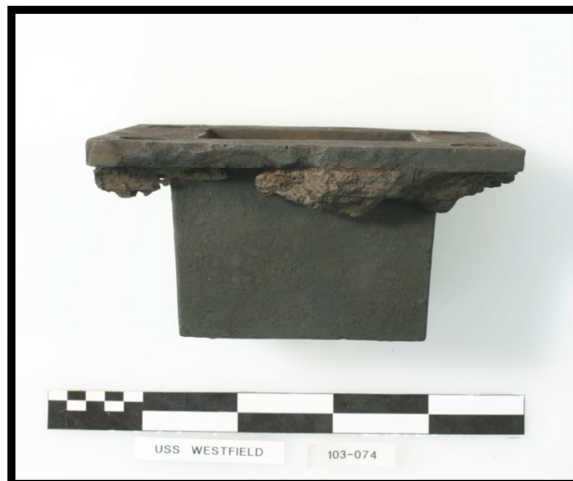
FIGURE 67. STANCHION SOCKET
(ARTIFACT 103-074; SCALE CM)

Behind the bulwarks *Westfield* was equipped with defensive netting to repel enemy boarding parties. The Memphis drawing (Figure 3) shows netting supported by stanchions on both the bow and stern decks. These stanchions were supported by sockets imbedded in the deck. One of these sockets survived intact (Artifact 103-074). The artifact is cast iron and still contains some of the wood from the original deck (Figure 67). Based on the socket size, the stanchion measured 2-1/2 x 3-3/4 inches thick at the bottom of the socket. A similar stanchion (Figure 68) was recovered from the Civil War steamer, USS *Otsego*, the difference being that the latter object was made of brass and contained smaller measurements (Diveley 2008:223). *Westfield* required numerous posts and sockets in order to support nets around each gun deck. A general idea of the socket arrangement can be inferred from Figure 69, in which an unknown converted ferry gunboat has all of the stanchions erected in their respective sockets.

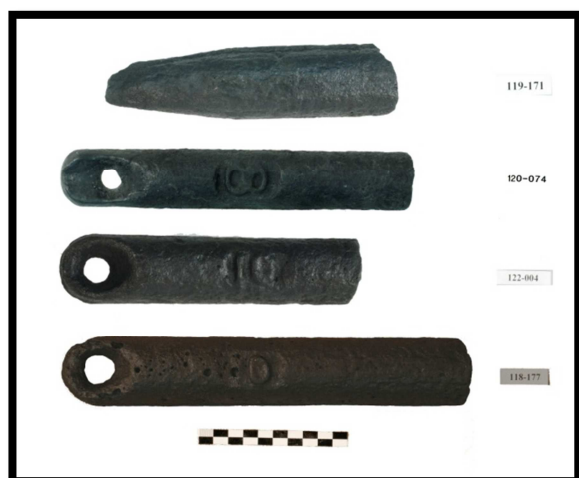
FIGURE 70. SASH WEIGHTS

During this period, sash weights were commonly used to counter balance the weight of large windows. This helped keep them open and prevented the windows from slamming down when being closed. Archeologists recovered numerous sash weights from *Westfield* (Figure 70). These weights may have been left over from when the vessel served as a ferryboat. During the rushed conversion of *Westfield*, and the removal of the large windows, many of the sash weights may have

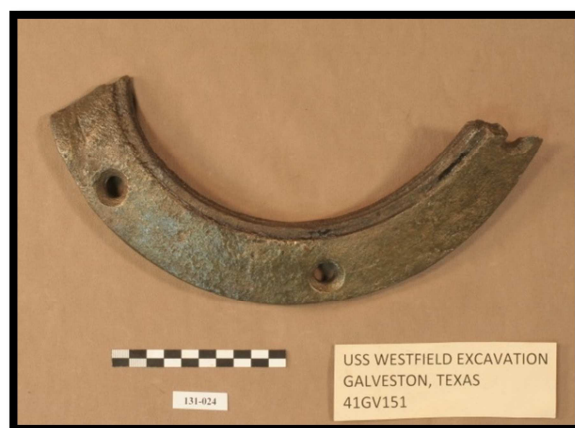
FIGURE 72. BRASS PORT HOLE FRAGMENT
(ARTIFACT 131-024)

Artifact 131-024 is also believed to have come from a porthole but having a smaller diameter than Artifact 124-034. The object consists of a bent brass rim fragment with recessed fastening holes and a series of parallel ribs on the inside circumference (Figure 72). The outer diameter is about 13 inches. The backside of the rim is hollowed out indicating that the artifact was part of a frame. The ribs lining the margin of the interior curve might have functioned to hold a gasket in place. This object resembles the outer supporting rim of a porthole frame that was mounted to a wall surface. The complete porthole likely included a second inner frame holding the glass that could be closed and tightened into the gasket to create a watertight seal (Figure 73).

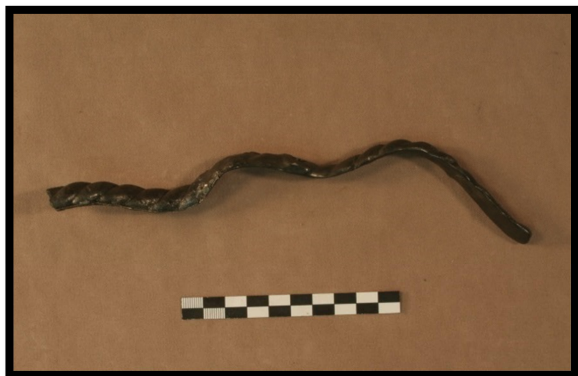
FIGURE 77. DECORATIVE DOORKNOB FRAME
(ARTIFACT 125-037)

Some cabin artifacts might have been either original hardware on the ferryboat or added (or reused) when *Westfield* was converted to a gunboat. It is difficult to determine which came from *Westfield's* time as a ferry and which were brought on board during naval conversion. One such artifact (125-037) consists of an elegant brass object decorated on the front surface to resemble a cord of rope (Figure 77). The back of the object is smooth, and the center contains a rounded hole. Conservators believe this object is a decorative frame, through which a doorknob turned. Other brass door pieces (Figure 78) consist of a strike plate for a door lock (Artifact 108-026), and a strike plate for a door knob (Artifact 109-099). A brass handrail bracket (Artifact 104-058) may have been part of a railing that lined the horse corridors and was kept aboard after naval conversion (Figure 79). Again, these objects cannot be easily dated. Railings could easily have been added after naval conversion to give crewmembers something to hold onto when traveling the hallways in rough seas.

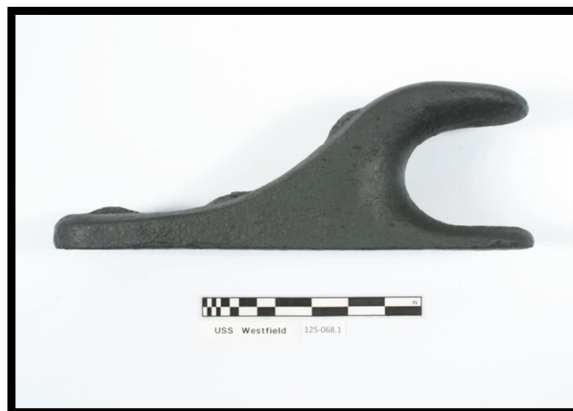
FIGURE 80. CAST IRON ROLLING CHOCK
(ARTIFACT 125-068; SCALE INCHES)

A single cast iron rolling chock (Artifact 125-068) was found near the stern area (Figure 80). This artifact was originally secured to the vessel with three fastening bolts. Like ships today, this object would have been used to guide securing lines when *Westfield* tied alongside another vessel or docked near land. Since the armored plates would have interfered with lines coming onto or leaving the vessel, the rolling chock may have been mounted on the outer guard. On the lowest part of the bulwarks, the water way timber allowed for deck drainage through scupper holes, and ropes or chains that passed through hawser pipes. An example of such a hawser pipe was recovered. Artifact 107-069 is made of lead and therefore likely received rope, since chains would have been too harsh on such a soft metal (Figure 81). The pipe measures 14.5 to 15 inches along the center excluding the flanges, consistent with the original bulwark thickness through which the pipe passed. On each end, the metal has been hammered down to create a rim or flange. Along the flanges, small holes indicate that the pipe was secured to the bulwarks with nails.

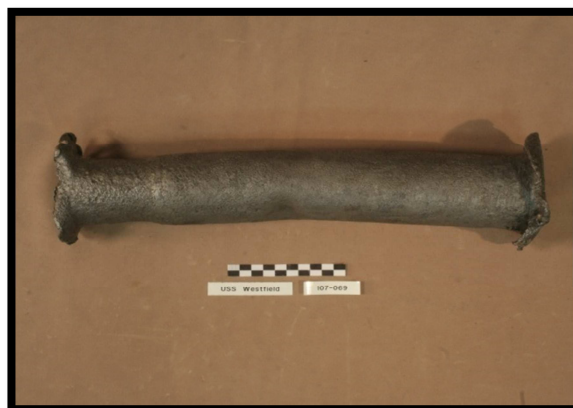
FIGURE 81. LEAD HAWSER PIPE
(ARTIFACT 107-069)

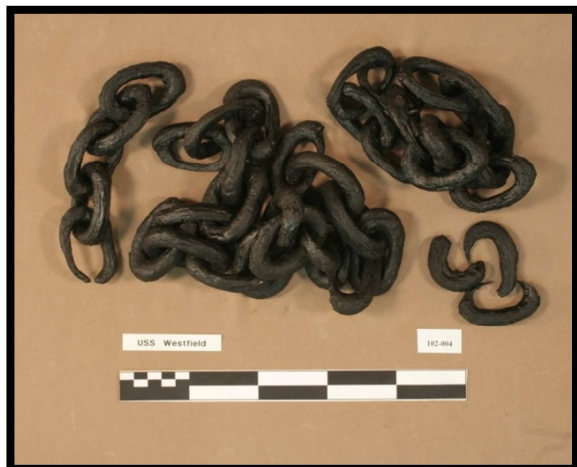
FIGURE 82. WROUGHT IRON CHAIN
(ARTIFACT 102-004; SCALE CM)

Excavations recovered nine chain segments from *Westfield*. The segments vary in length and preservation, but all were determined to have come from the same size/type of chain (Figure 82). Five of the segments were found across three sequential grids (102, 103, and 104), starting in what archeologists believe was *Westfield's* stern area, and moving east towards the former main cabin. The chain is too small for securing cannon tackle or to be used for hauling the anchors. Based on the recovered locations, these chains may have been used to steer *Westfield's* stern rudder. The chains would have connected beneath the deck on both sides of the rudder, and then would have run under the main cabin, before being redirected on chain rollers, up into the rear pilot house. For comparison, similar sized rudder chains can be seen on the steamboat *Ticonderoga* (Figure 83).

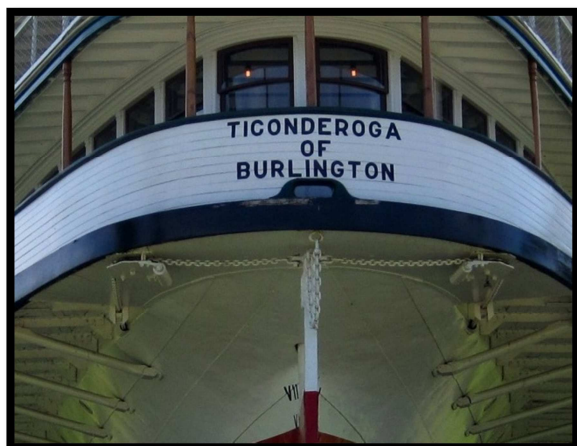
FIGURE 83. RUDDER CHAINS ON
STEAMBOAT *TICONDEROGA*

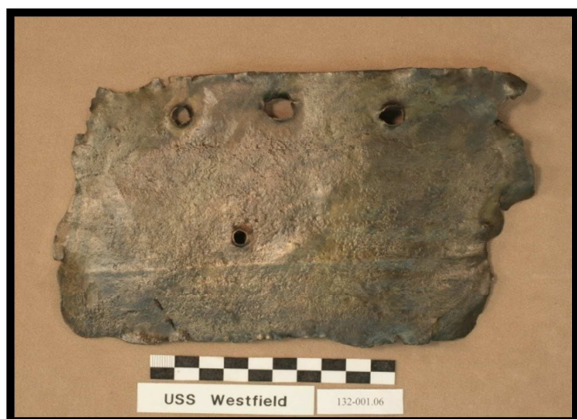
FIGURE 84. COPPER HULL SHEATHING
(ARTIFACT 132-001.06)

Westfield's hull is known from Confederate salvage accounts to have been sheathed with copper below the waterline. The use of copper sheathing was a time-honored method to protect the wood hull from *teredo* consumption and also to reduce fouling. Copper does not form concretion (unless in contact with or in close proximity to iron) and would have been easy to identify, yet very little copper sheathing was recovered from the site. It is likely that Confederate salvers removed any sheathing accessible from the sides of *Westfield's* hull. Substantial portions of sheathing should have remained, following their salvage efforts; however, by 1906, when additional materials were removed from the site, very little hull remained. Once wooden portions of the ship had deteriorated, storm currents might easily have carried the remaining sheathing away. Only two small fragments of sheathing were recovered (Artifact 132-1.6 and Artifact 133-114). Artifact 132-1.6 (Figure 84) was screened from sediment that was inside the firebox. Along the upper edge of the fragment are attachment holes for the sheathing tacks; these are spaced between 1.5 and 1.8 inches apart and are inset about 0.5 inches.

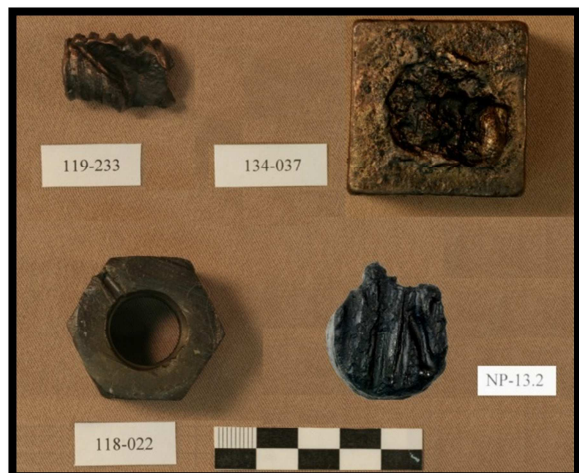
FIGURE 88. ARTIFACTS WITH HACK AND SAW MARKS (ARTIFACT 118-022, 119-233, 134-037, & NP-13.2; SCALE MM/CM)

A few of these artifacts (118-022, 119-233, 134-037, and NP-13.2) display saw and hack marks that indicate the objects were removed intentionally by force (Figure 88). One of the most obvious artifacts to display these marks (Artifact 138-051.1) appears to be fastener related, but also contains decorative circles molded into the metal. This artifact was sawn off at an angle, leaving distinct teeth marks in the metal before the saw broke through and ripped off part of the edge (Figure 89).

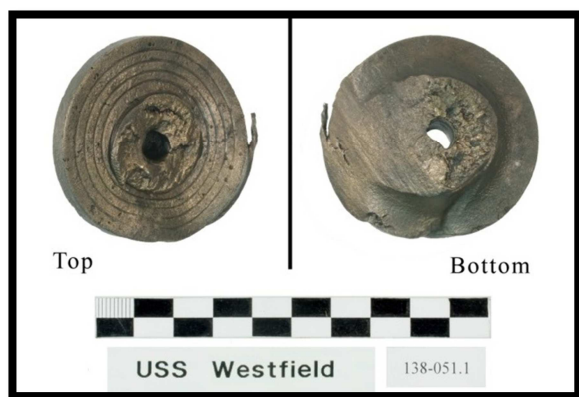
FIGURE 89. SAWN ROUNDED ARTIFACT (ARTIFACT 138-051.1; SCALE MM/CM)

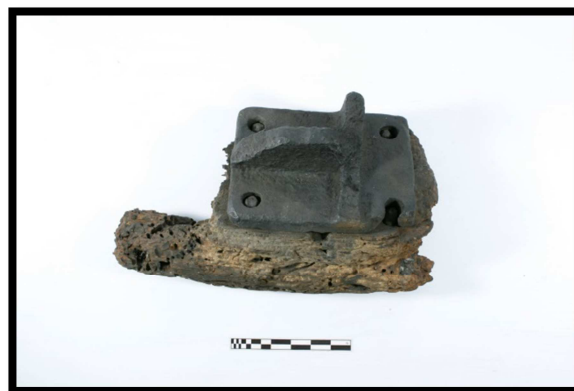
FIGURE 90. LARGE WOOD FRAGMENT WITH IRON FIXTURE (ARTIFACT 108-130; SCALE INCHES)

The largest surviving wood fragment (Artifact 108-130) measures approximately 16 inches long x 8 inches thick (including the bracket) x 7.5 inches wide. This artifact survived because of a large cast iron fixture that is attached to the wood's top surface. The fixture has heavy raised projections or ridges presumably designed to support another structure. An illegible three-digit number (possibly 082, 532 or 522) is embossed on the surface of one projection. Four bolts that did not survive once attached the object to the wood. On the underside of the fixture, an additional ridge was received by a channel cut into the wood. This mortise and tenon-like feature would have helped prevent the fixture from sliding and placing too much lateral strain on the bolts. Although the purpose of this fixture is not known, the object was reinforced to support a heavy load (Figure 90).

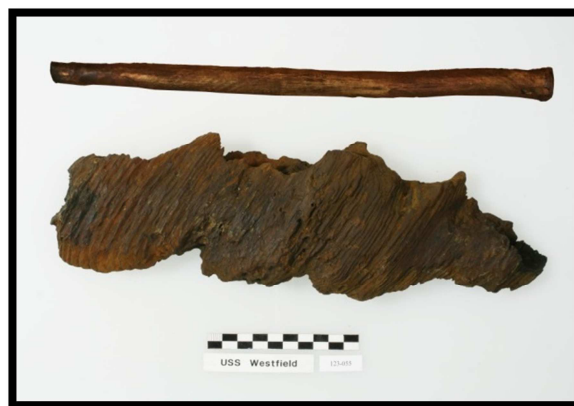
FIGURE 91. BOLT AND WOOD FRAGMENT ERODED FROM CURRENTS (ARTIFACT 123-055; SCALE CM)

A second artifact (123-055) consists of a wood fragment and a brass bolt (Figure 91). Both the bolt and the wood have been scoured by currents and over time, worn down and polished. While the artifact does not offer much information regarding hull construction, the deep erosion marks on the wood's surface reflect the high energy currents that passed over the wreck site, contributing to the disintegration of *Westfield's* hull.

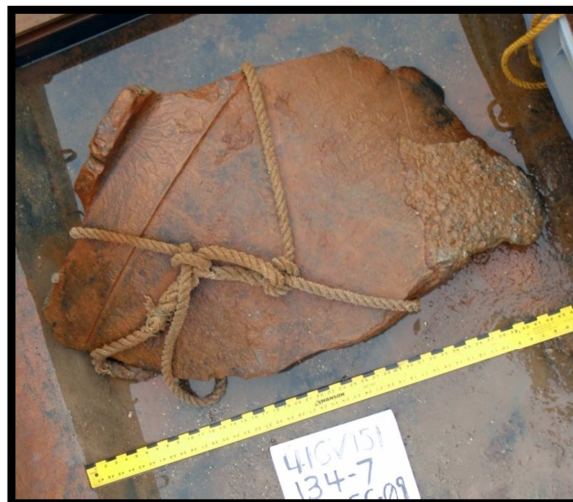
FIGURE 96. LARGE CYLINDER FRAGMENT (ARTIFACT 134-007; SCALE INCHES)

Several fragments of *Westfield's* cylinder and condenser assembly have been identified, of which four are of considerable size (Figure 96). All of these fragments have a curvature consistent with a diameter of 50 inches, matching the historical record. Most engine cylinders had a wall thickness of 1 to 1.5 inches but also incorporated stiffening rings spaced evenly along the cylinder assembly as a method of reinforcement (Whittier 1983:15). *Westfield's* cylinder and condenser artifacts are 1 inch thick and many exhibit stiffening rings measuring 5 inches high and 0.5 inches thick (in addition to the wall thickness). All four of the larger curved fragments can be identified as coming from the lower condenser. Although heavily weathered, Artifact 132-016 still contains a broken remnant of the dividing plate that separated the condenser from the upper cylinder (Figure 97). Two of the artifacts (132-006 and 138-001), are still bolted to the base plate that formed the condenser's foundation (figures 98 and 99). In order to secure the engine cylinder and condenser together to the lower base plate, the ends of each cylindrical component contain a 1-inch-thick lip, 4 inches wide. On this lip, fastening bolts are spaced 6.5 inches apart. In total, four base plate fragments were recovered (132-001.91, 132-006, 138-001, and 140-004). These plates are 1.75 inches thick. During initial de-concretion efforts, conservators noticed that all of these plates retained wooden splinters on their undersides from the massive bed frame timbers that formed the foundation of the entire engine. Amazingly, Artifacts 132-006 and 138-001, along with Artifact 134-007 (no base plate) still fit together and can be rejoined along their fracture points (Figure 100). Based on the rejoining of these artifacts and the known orientation of *Westfield's* engine (condenser/engine cylinder aft, air pump/hot well forward), conservators were able to determine that these three artifact came from the starboard side of the vessel. Following the bolt pattern on these joined artifacts, base plate Artifact 132-001.91, which could not be rejoined, came from *Westfield's* port side (Figure 101).

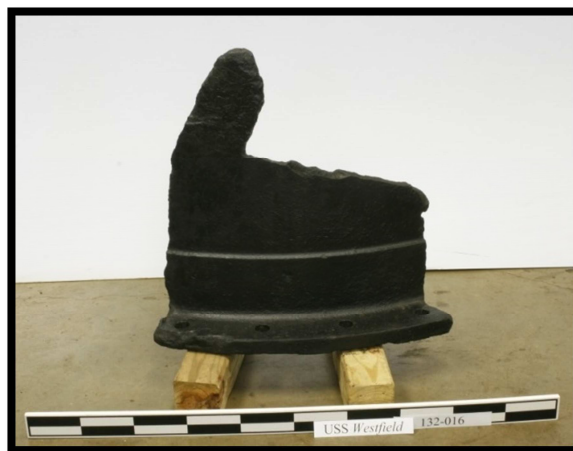
FIGURE 97. FRAGMENT FROM TOP OF CONDENSER (ARTIFACT 132-016; SCALE DM)

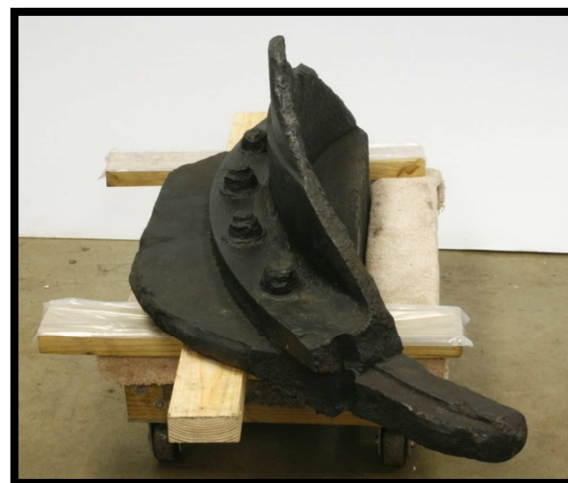
FIGURE 98. FRAGMENT OF CYLINDER ON BASEPLATE (ARTIFACT 138-001)

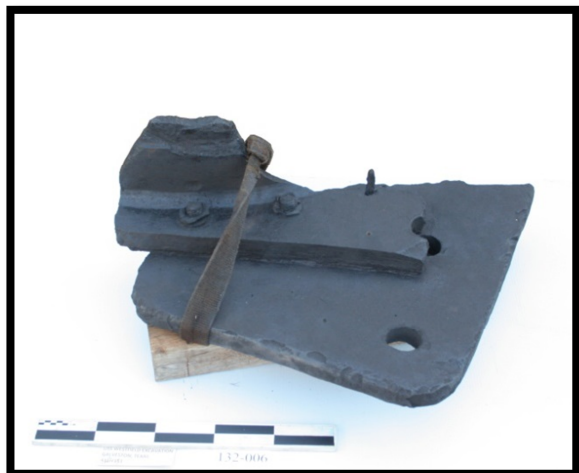
FIGURE 99. FRAGMENT OF CYLINDER ON BASEPLATE
(ARTIFACT 132-006; SCALE CM/DM)

through rounded holes in the base plate as seen in figures 99 and 104. Each hole had a diameter of 2 to 2.25 inches. Cast iron washers lay between the square nut and the plate surface (Figure 109). The washers acted as a sacrificial surface that could rotate if needed and spread the load placed on the bolt heads (Jim Jobling, personal communication 2014). A variant of this bolt type was also recovered (Artifact 132-001.92). Rather than containing a smaller square nut and an underlying washer, this bolt instead utilized a single larger wrought iron nut that accomplished both tasks (Figure 110).

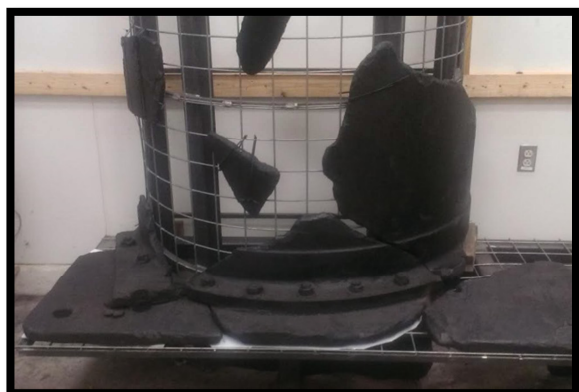
FIGURE 100. REJOINED CYLINDER FRAGMENTS
(ARTIFACTS 132-006, 138,001, & 134-007)
